# Certified Home Inspection Service

## INSPECTION REPORT

**3715 S. 3rd St. Burlington, WA 98233.**

**CLIENT'S NAME:** Mr. & Mrs Smith.  
**DATE OF INSPECTION:** June 23, 2007.  
**INSPECTOR:** Keith Schenk - Certified Inspector.

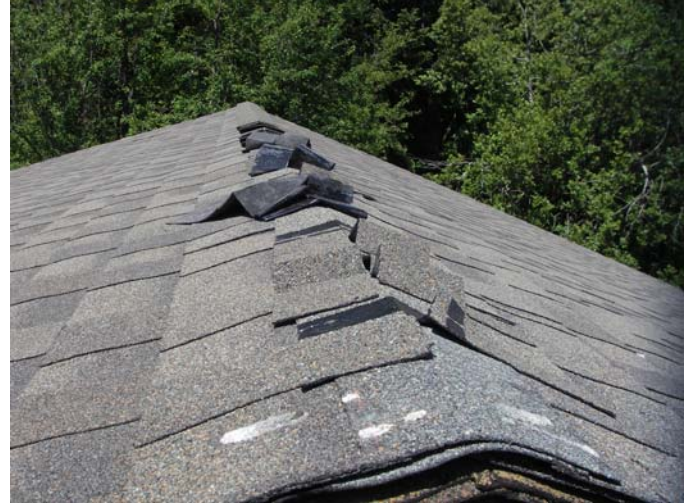
Ridge is damaged. Contact a licensed Roofing Contractor for repair.

Damaged or missing Shingles noted. Repair/Replacement needed.

**STRUCTURAL CONDITION:** Further evaluation/repair is recommended by a licensed Roofing Contractor.

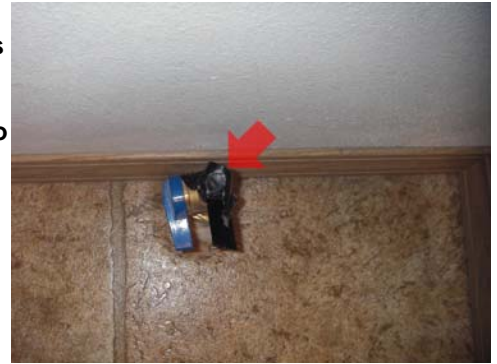
An easy operate hand shut-off valve is properly installed on the gas line. The valve is not plugged. This is an unsafe condition that may allow deadly gases to enter the house if the valve is bumped open. This valve needs to be plugged.

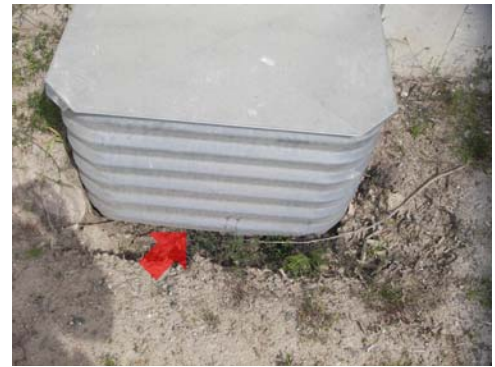
**FOUNDATION CONDITION:** Acceptable.  
**STEM WALL:** Concrete.  
**FOUNDATION CRACKS:** Typical hairline cracks were observed = Monitor.  
**ANCHOR BOLTS:** Installed.  
**OTHER OBSERVATIONS:** The bottom of the metal crawl space cover is not buried and allows rodent access into the crawl space. The opening needs to be filled.
